An Unusual Cause of Pacemaker Lead Displacement: 'Reverse Ratchet' Syndrome

Haytham Enab, Colin Cunningham and Amir Zaidi

Manchester Heart Centre, Manchester Royal Infirmary, Manchester, UK

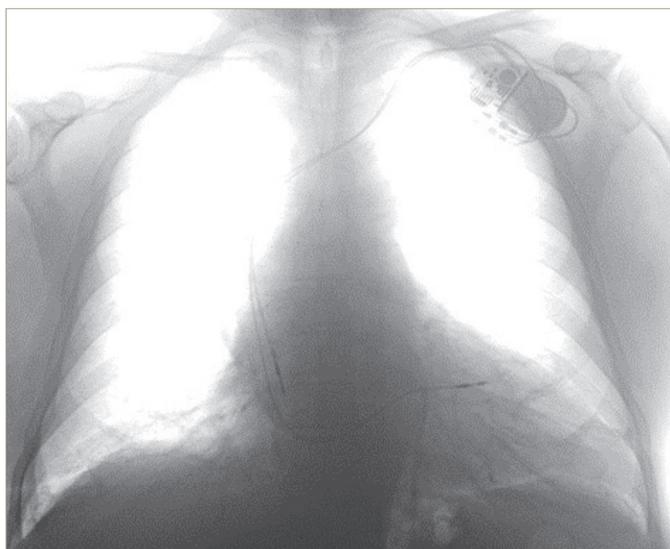
An 89-year-old man underwent implantation of a dual-chamber pacemaker in August 2017 for sinus node dysfunction (Dual chamber Abbott/St Jude Assurity – MRI 2272 pacemaker), with bipolar Abbott/St Jude leads 2088TC 58 cm and 52 cm [all Abbott Laboratories, Chicago, IL, USA]), with no acute complications. The right ventricular (RV) lead was implanted in a septal position, with an implant threshold of 1.9 V at a pulse duration of 0.4 msec. The post-procedural chest X-ray can be seen in *Figure 1*.

Figure 1: Chest X-ray taken in August 2017, after device implantation

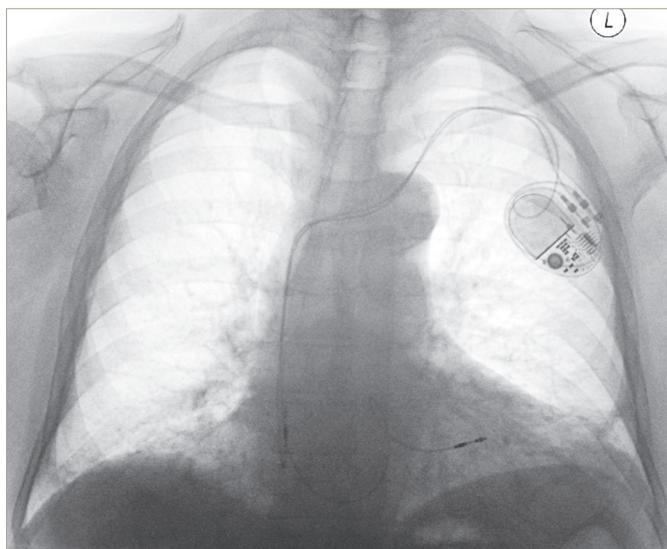
During a routine pacemaker follow-up in May 2018, it was noted that the RV threshold had increased to 3.9 V at a 0.4 ms pulse duration. RV lead impedance was stable and RV bipolar sensing was measured at 7.2 mV.

A repeat chest X-ray was performed, which showed no displacement of the RV lead tip, but revealed a loop of RV lead in the RV outflow tract that was not present on the previous chest X-ray (*Figure 2*). The position of the atrial lead was unchanged. As the RV pacing burden was very low (<5%), it was decided not to reposition the RV lead at that stage, but to continue monitoring the RV lead threshold.

Figure 2: Chest X-ray taken in May 2018, with the lead loop noticed

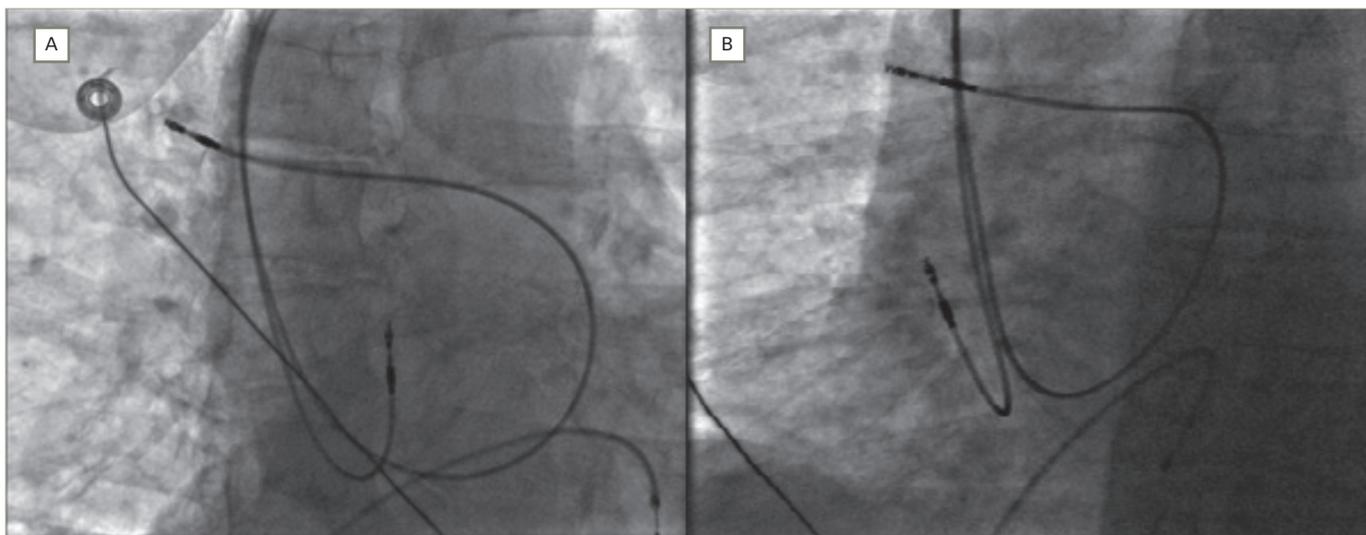
In June 2019, persistent noise was noted on the RV lead. The RV lead threshold was 7.25 V @ 1.0 ms bipolar and 1.0 V @ 0.4 ms unipolar. The RV pacing was reprogrammed to unipolar, with RV bipolar sensing measured at 4.5 mV. The patient was asymptomatic; however, he was scheduled for RV lead revision. Prior to opening the pacemaker, fluoroscopy of the leads pocket demonstrated that the RV lead had been displaced, with the lead tip now located within the right pulmonary artery (*Figure 3*). The lead was extracted with simple traction and a new RV lead was implanted at the RV apex.

Here we present the case of a patient in whom the RV pacemaker lead migrated to the pulmonary artery due to progressive slack in the lead over time. We refer to this case as an example of 'reverse ratchet' syndrome. Serial chest X-rays showed advancement of lead slack into the central circulation, with eventual displacement of the RV lead. It is noted that the pacemaker orientation changes before eventual displacement of the lead into the RV outflow tract, and then into the pulmonary artery. The lead slack advanced due to a loose lead fixation (suturing) sleeve, arm movements and anticlockwise rotation of the pacemaker. The combination of these factors resulted in this reverse ratchet syndrome.

Figure 3: Chest X-ray showing the right ventricular lead displaced into the pulmonary artery

A: anteroposterior view; B: lateral view

In the case we have presented, the patient did not show any symptoms relating to pacemaker lead displacement. Lead slack progressed over a long period, and displacement was seen relatively late. The pacemaker had rotated anticlockwise with the lead slack causing a loop in the RV lead in the RV outflow tract, which eventually led to the retraction of the RV lead tip from the RV implantation position and displacement into the pulmonary artery.

Patient education about post-pacemaker implant care, creating an appropriately-sized pocket for the generator, tying the lead fixation sleeves so they are sufficiently tight and fixing the battery to the pocket tissue with a strong suture can be used to avoid lead displacement, a well-known complication of device implantation.^{1,2} □
