# An Unusual Cause of Pacemaker Lead Displacement: 'Reverse Ratchet' Syndrome

Haytham Enab, Colin Cunnington and Amir Zaidi

Manchester Heart Centre, Manchester Royal Infirmary, Manchester, UK

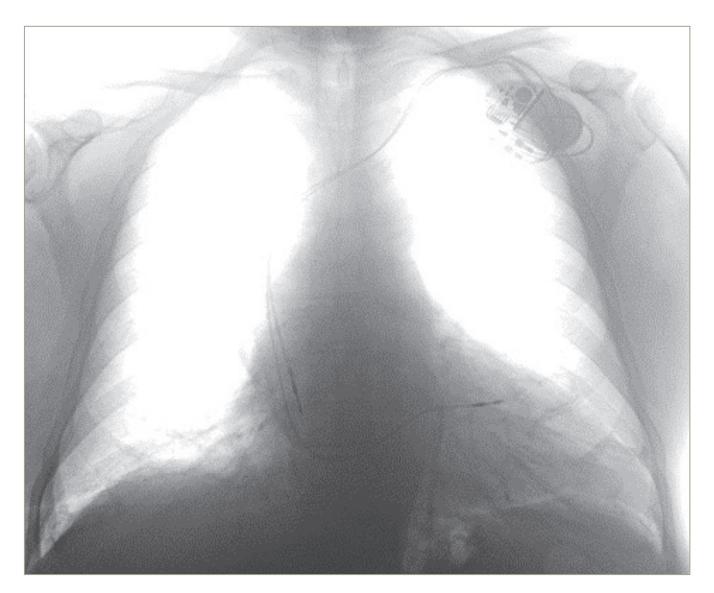
An 89-year-old man underwent implantation of a dual-chamber pacemaker in August 2017 for sinus node dysfunction (Dual chamber Abbott/St Jude Assurity – MRI 2272 pacemaker), with bipolar Abbott/St Jude leads 2088TC 58 cm and 52 cm [all Abbott Laboratories, Chicago, IL, USA]), with no acute complications. The right ventricular (RV) lead was implanted in a septal position, with an implant threshold of 1.9 V at a pulse duration of 0.4 msec. The post-procedural chest X-ray can be seen in *Figure 1*.

Figure 1: Chest X-ray taken in August 2017, after device implantation

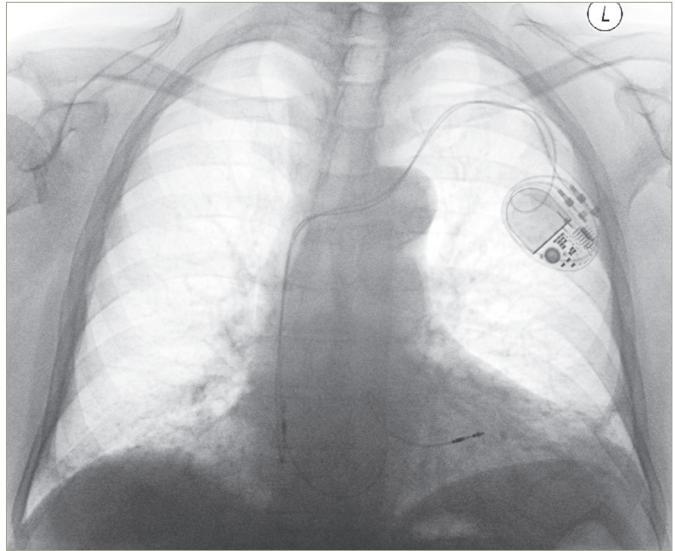
A repeat chest X-ray was performed, which showed no displacement of the RV lead tip, but revealed a loop of RV lead in the RV outflow tract that was not present on the previous chest X-ray (*Figure 2*). The position of the atrial lead was unchanged. As the RV pacing burden was very low (<5%), it was decided not to reposition the RV lead at that stage, but to continue monitoring the RV lead threshold.

Figure 2: Chest X-ray taken in May 2018, with the lead loop noticed

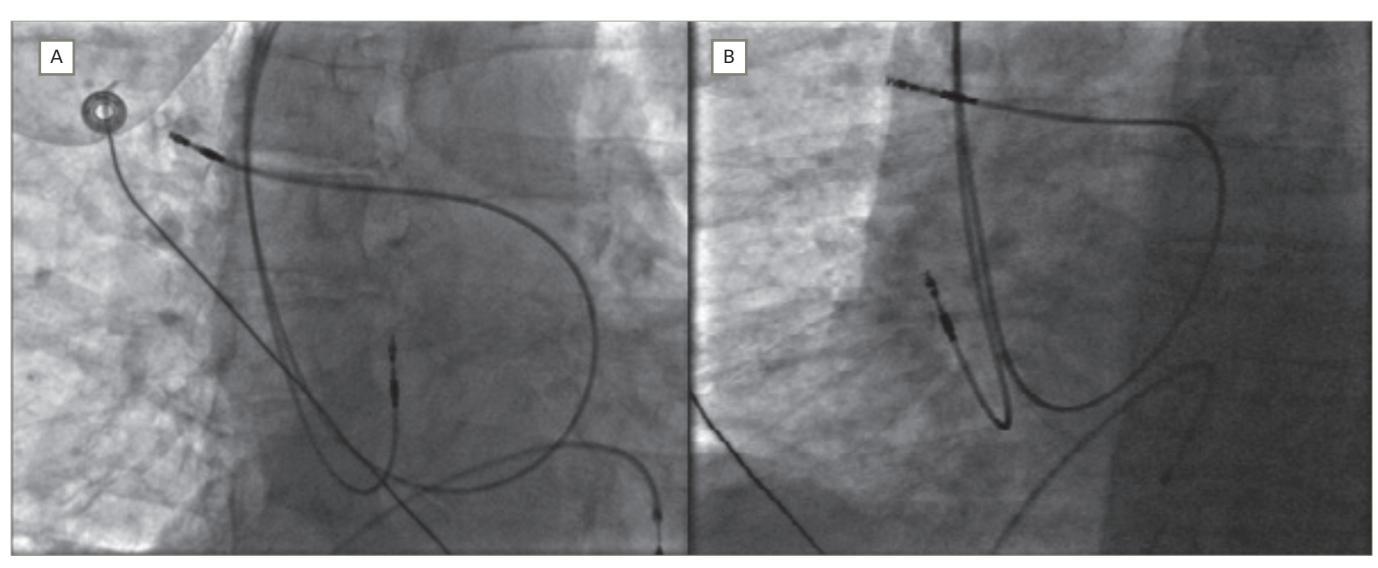
In June 2019, persistent noise was noted on the RV lead. The RV lead threshold was  $7.25 \vee @ 1.0 \text{ ms}$  bipolar and  $1.0 \vee @ 0.4 \text{ ms}$  unipolar. The RV pacing was reprogrammed to unipolar, with RV bipolar sensing measured at 4.5 mV. The patient was asymptomatic; however, he was scheduled for RV lead revision. Prior to opening the pacemaker, fluoroscopy of the leads pocket demonstrated that the RV lead had been displaced, with the lead tip now located within the right pulmonary artery (*Figure 3*). The lead was extracted with simple traction and a new RV lead was implanted at the RV apex.

Here we present the case of a patient in whom the RV pacemaker lead migrated to the pulmonary artery due to progressive slack in the lead over time. We refer to this case as an example of 'reverse ratchet' syndrome. Serial chest X-rays showed advancement of lead slack into the central circulation, with eventual displacement of the RV lead. It is noted that the pacemaker orientation changes before eventual displacement of the lead into the RV outflow tract, and then into the pulmonary artery. The lead slack advanced due to a loose lead fixation (suturing) sleeve, arm movements and anticlockwise rotation of the pacemaker. The combination of these factors resulted in this reverse ratchet syndrome.

Figure 3: Chest X-ray showing the right ventricular lead displaced into the pulmonary artery

A: anteroposterior view; B: lateral view

Patient education about post-pacemaker implant care, creating an appropriately-sized pocket for the generator, tying the lead fixation sleeves so they are sufficiently tight and fixing the battery to the pocket tissue with a strong suture can be used to avoid lead displacement, a well-known complication of device implantation.<sup>12</sup>
