# Cardiac magnetic resonance imaging of a patient with an magnetic resonance imaging conditional permanent pacemaker

ated risks. No reports have been published regarding the use of such devices with cardiac MRI in a clinical setting. We present the safe, successful cardiac MRI scan of a patient with an MRI-conditional permanent pacing system.

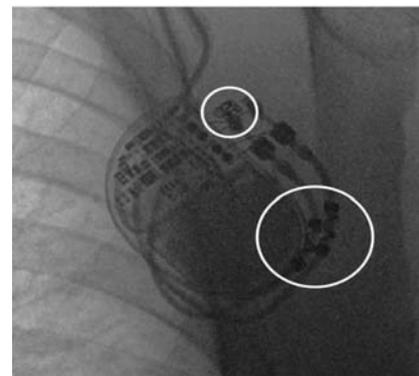
Figure 1. Chest X-ray, enlarged image of generator box. Radio-opaque labels are present on the lead (large circle) and device (smaller circle) to indicate that the device can be used with magnetic resonance imaging.

tainty of the underlying diagnosis, the pacing system selected for implant was a Medtronic EnRhythm MRI™ SureScan™ dual chamber device and CapSureFix MRI™ leads (Figure 1). This pacing system (generator box and leads) is the first to be designed to be compatible with MRI scanning under pre-defined conditions;<sup>11</sup> in general terms, these conditions include marginal limitation of the magnetic field and ensuring that the pacemaker is well established and functioning reliably.

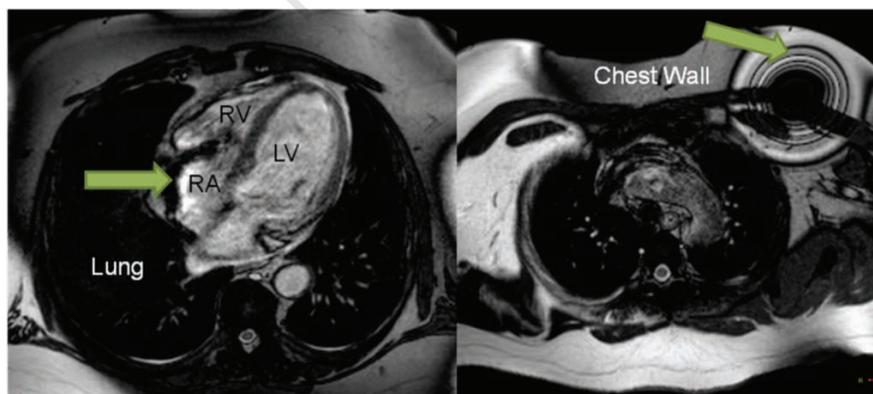
**Figure 2.** Still images taken from balanced steady state free precession (bSSFP) cine image acquisition. Trans-axial view of the heart (left hand panel) showing lead artefact (arrow) in the right atrium (RA) and right ventricle (RV). Trans-axial view of the pre-pectoral pocket (right hand panel) showing artefact from the pacemaker generator box (arrow): artefact did not compromise the quality of data interpretation.

Diagnostic quality images were acquired, including first pass adenosine stress perfusion imaging, and early and late gadolinium enhanced imaging. A minor degree of artefact

was reported due to dephasing (Figures 2 and 3) which did not compromise the quality of data interpretation.

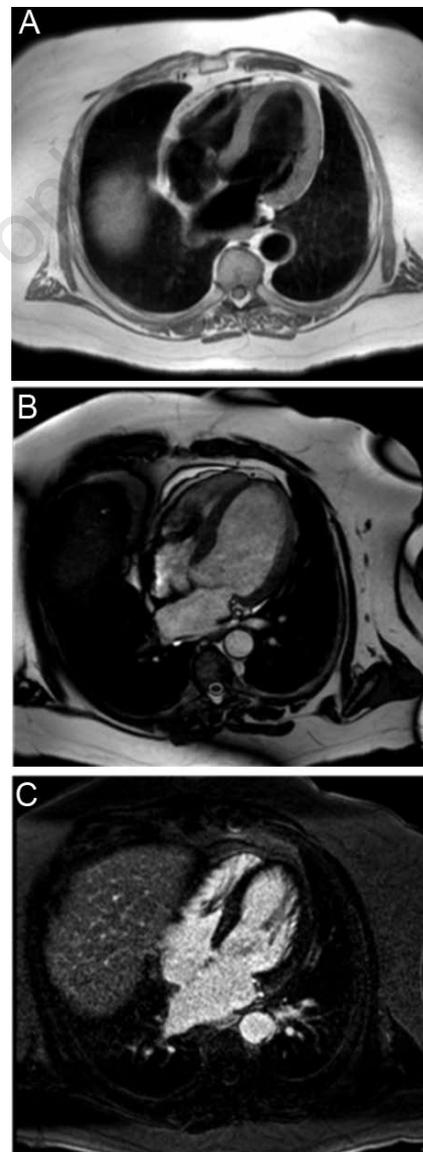
**Figure 3.** (A) Four chamber orientation of the heart using black blood imaging showing a small amount of artefact in the right atrium. (B) Still image from a bSSFP cine clip showing excellent resolution with only minimal artefact. (C) Late gadolinium enhanced imaging showing absence of left ventricular scarring, again with minimal interference from the pacing leads.
